**THE BUREAU OF OCEAN ENERGY MANAGEMENT,
REGULATION AND ENFORCEMENT**

**VERMILION BLOCK, PRODUCTION PLATFORM A:
AN INVESTIGATION OF THE SEPTEMBER 2, 2010 INCIDENT
IN THE GULF OF MEXICO**

May 23, 2011

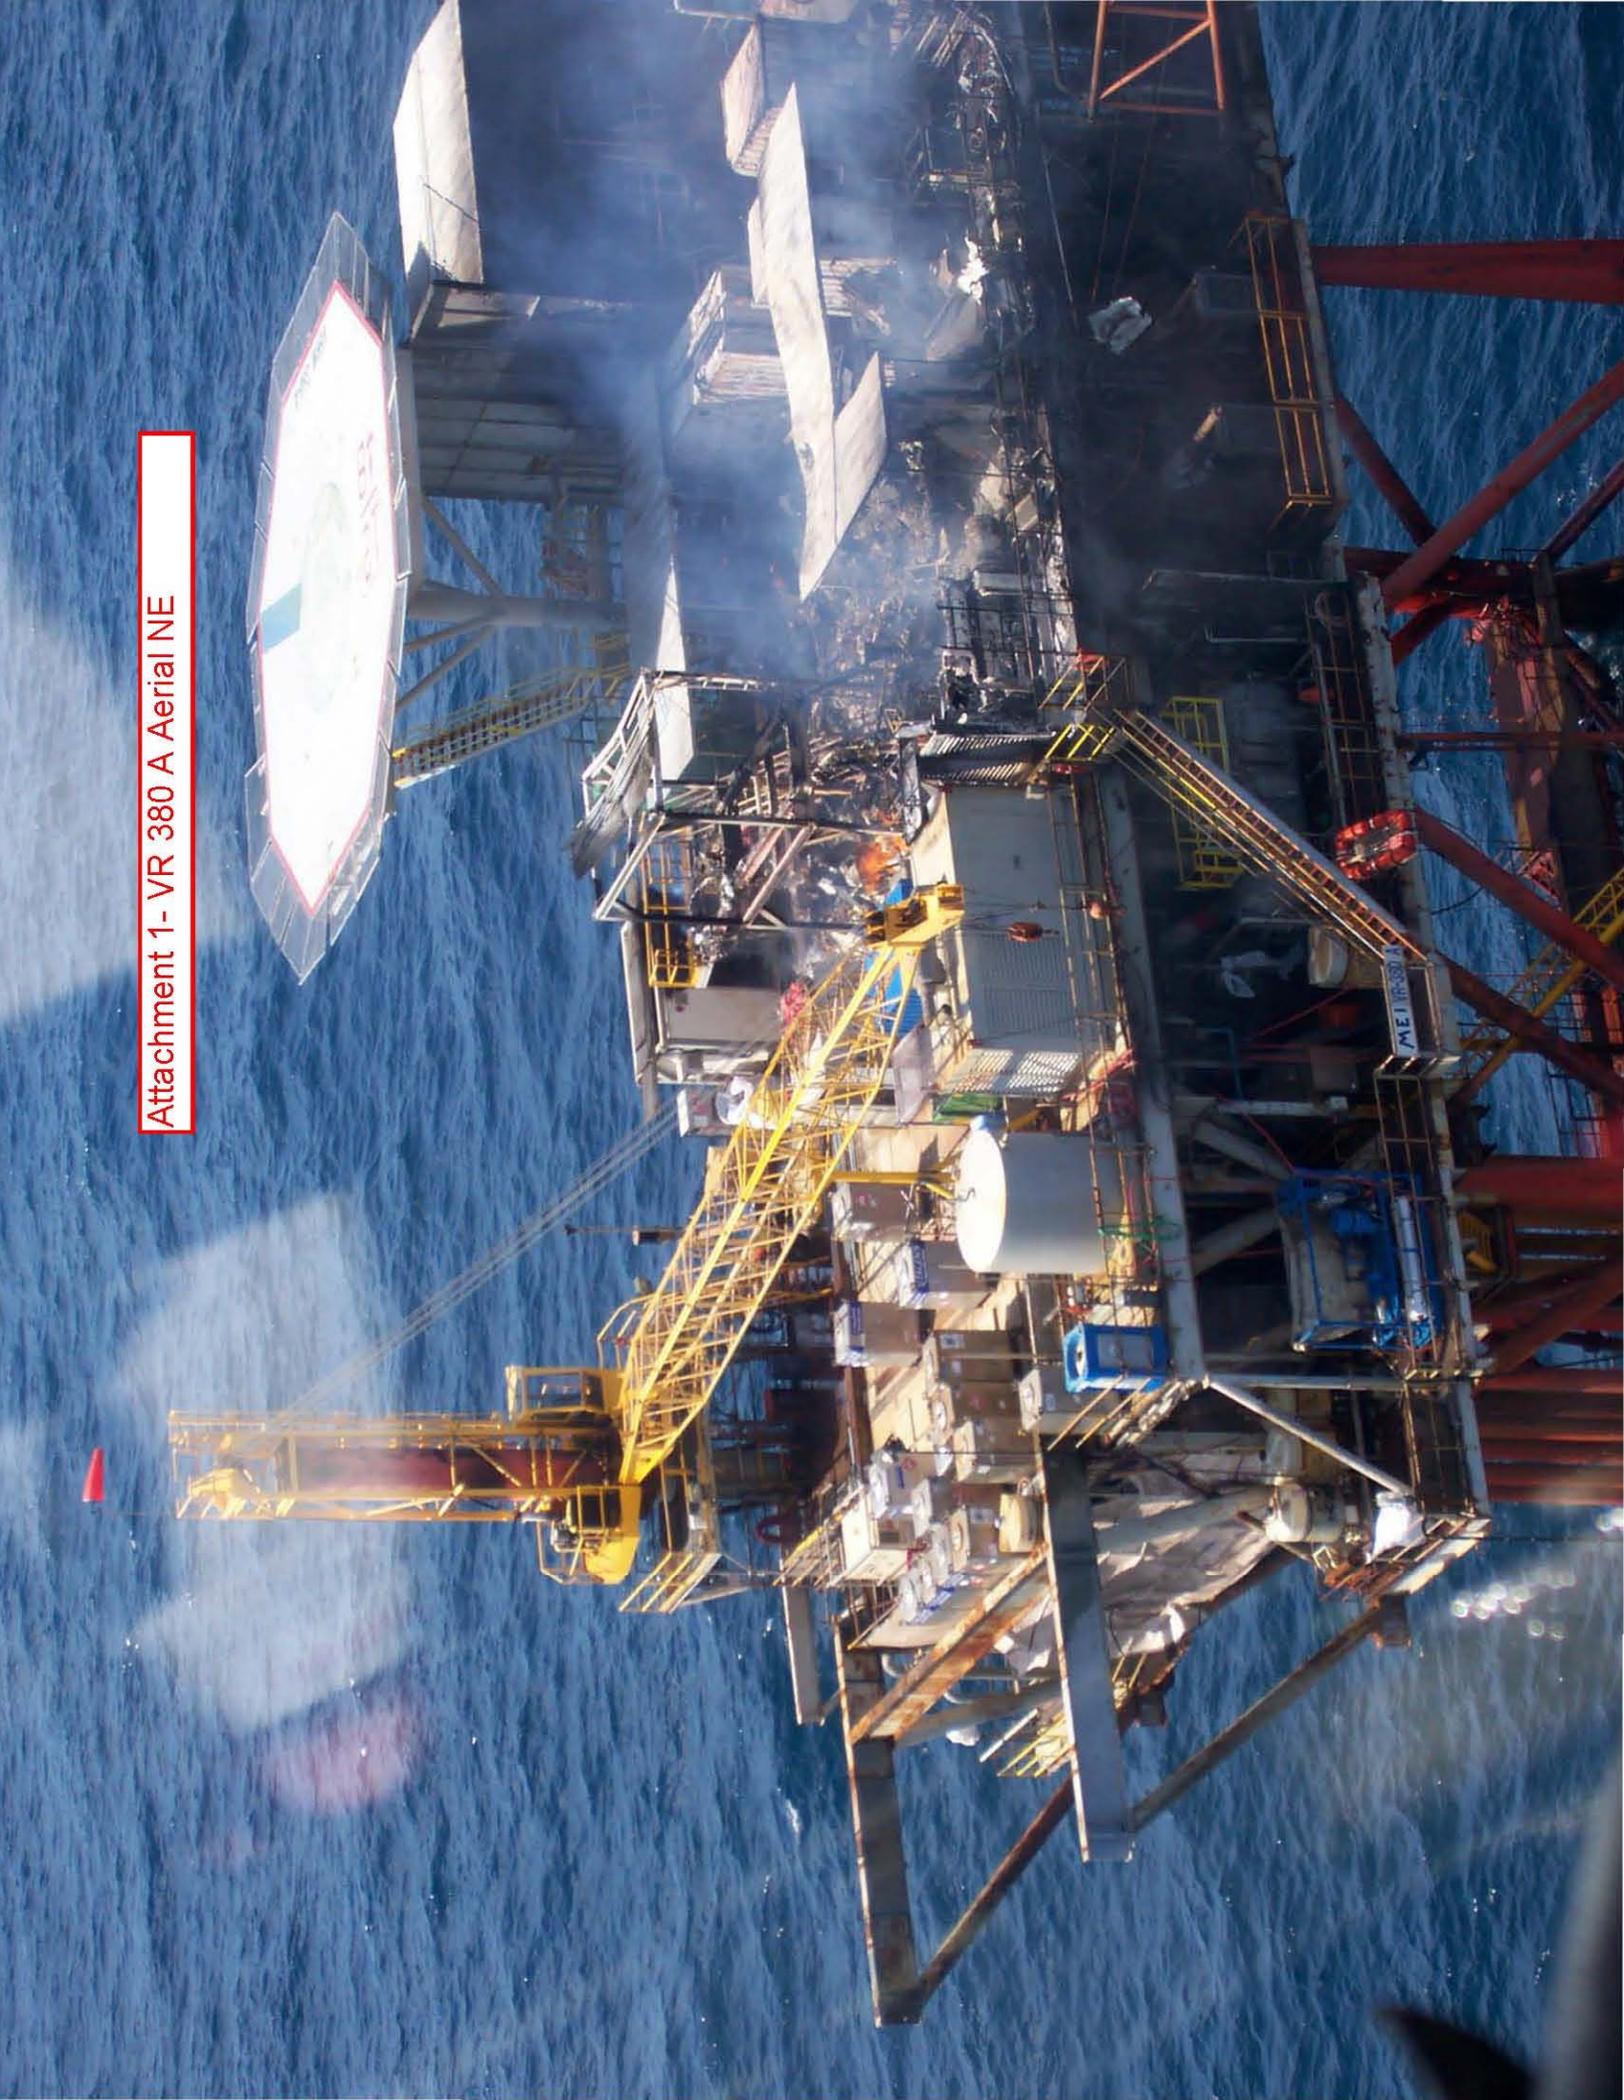
Attachment 1- VR 380 A Aerial NE

BOEMRE personnel concluded that the fire affected both the cellar and main decks of the Platform. For instance, on the main deck, the effects of the fire were visible in the center and the western areas of the platform -- the sleeping quarters, galley, MCC building, gas generator, several storage tanks, and storage buildings all sustained major damage or were totally destroyed. The switchgear building also was damaged. The fire on the cellar deck appeared mainly confined to the north, center, and western bay areas, which contained two out-of-service gas-driven pipeline pumps, the LACT charge pumps, "good" and "bad" oil tanks, and the Heater-Treater and Vent Scrubber, respectively. The components located in the north and center bays⁹ sustained varying levels of damage, which ranged from minimal to severe.

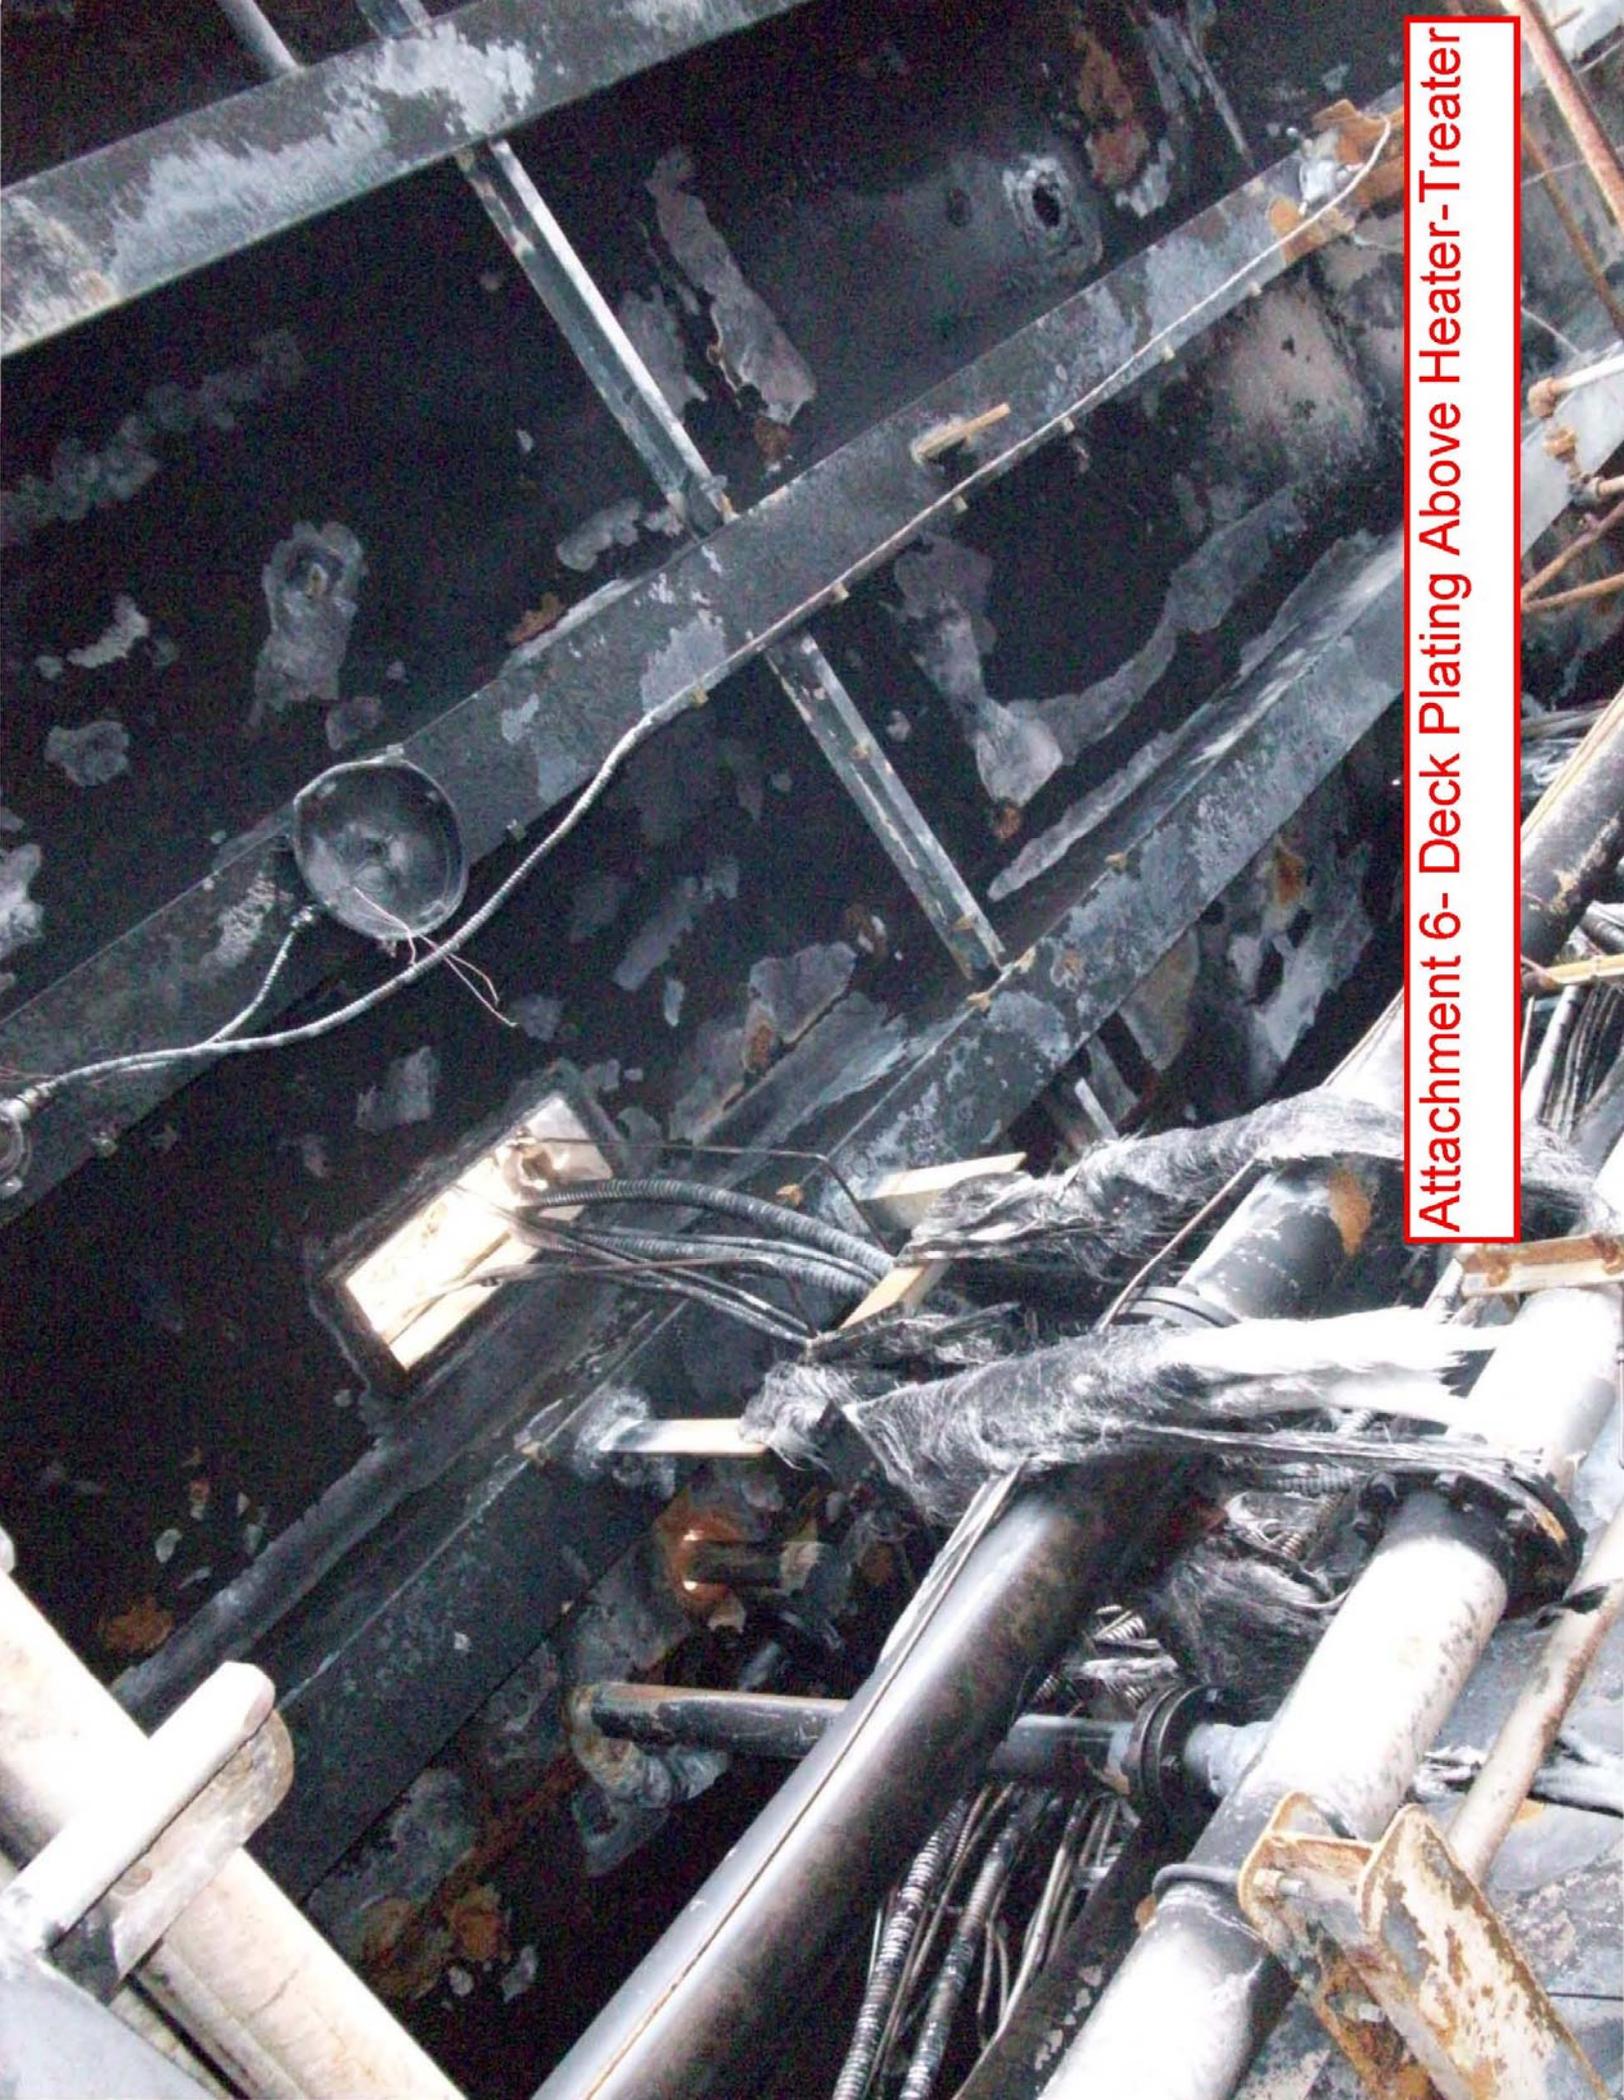
Attachment 6- Deck Plating Above Heater-Treater

BOEMRE personnel also noticed that the fire walls and deck plating near and above the Heater-Treater were affected by the fire. These barriers appeared to function as intended by helping minimize damage to the Platform. They also observed that ignited liquids appeared to have burned the floor in the area near the Heater-Treater, and that the fire spread on the floor from the Heater-Treater to the area where the "out of service" pipeline pumps and good and bad oil storage tanks were located. Furthermore, the Heater-Treater's electronic control panel, pneumatic slave panel and flame signal panel sustained significant fire damage or were destroyed.¹⁰ The Heater-Treater's slave panel was seriously damaged and bent away from the front end of the Heater-Treater. The damage to these panels impaired the Panel's ability to conduct testing on them, and to reach conclusions regarding possible malfunctions or warning signals in the panels.¹¹

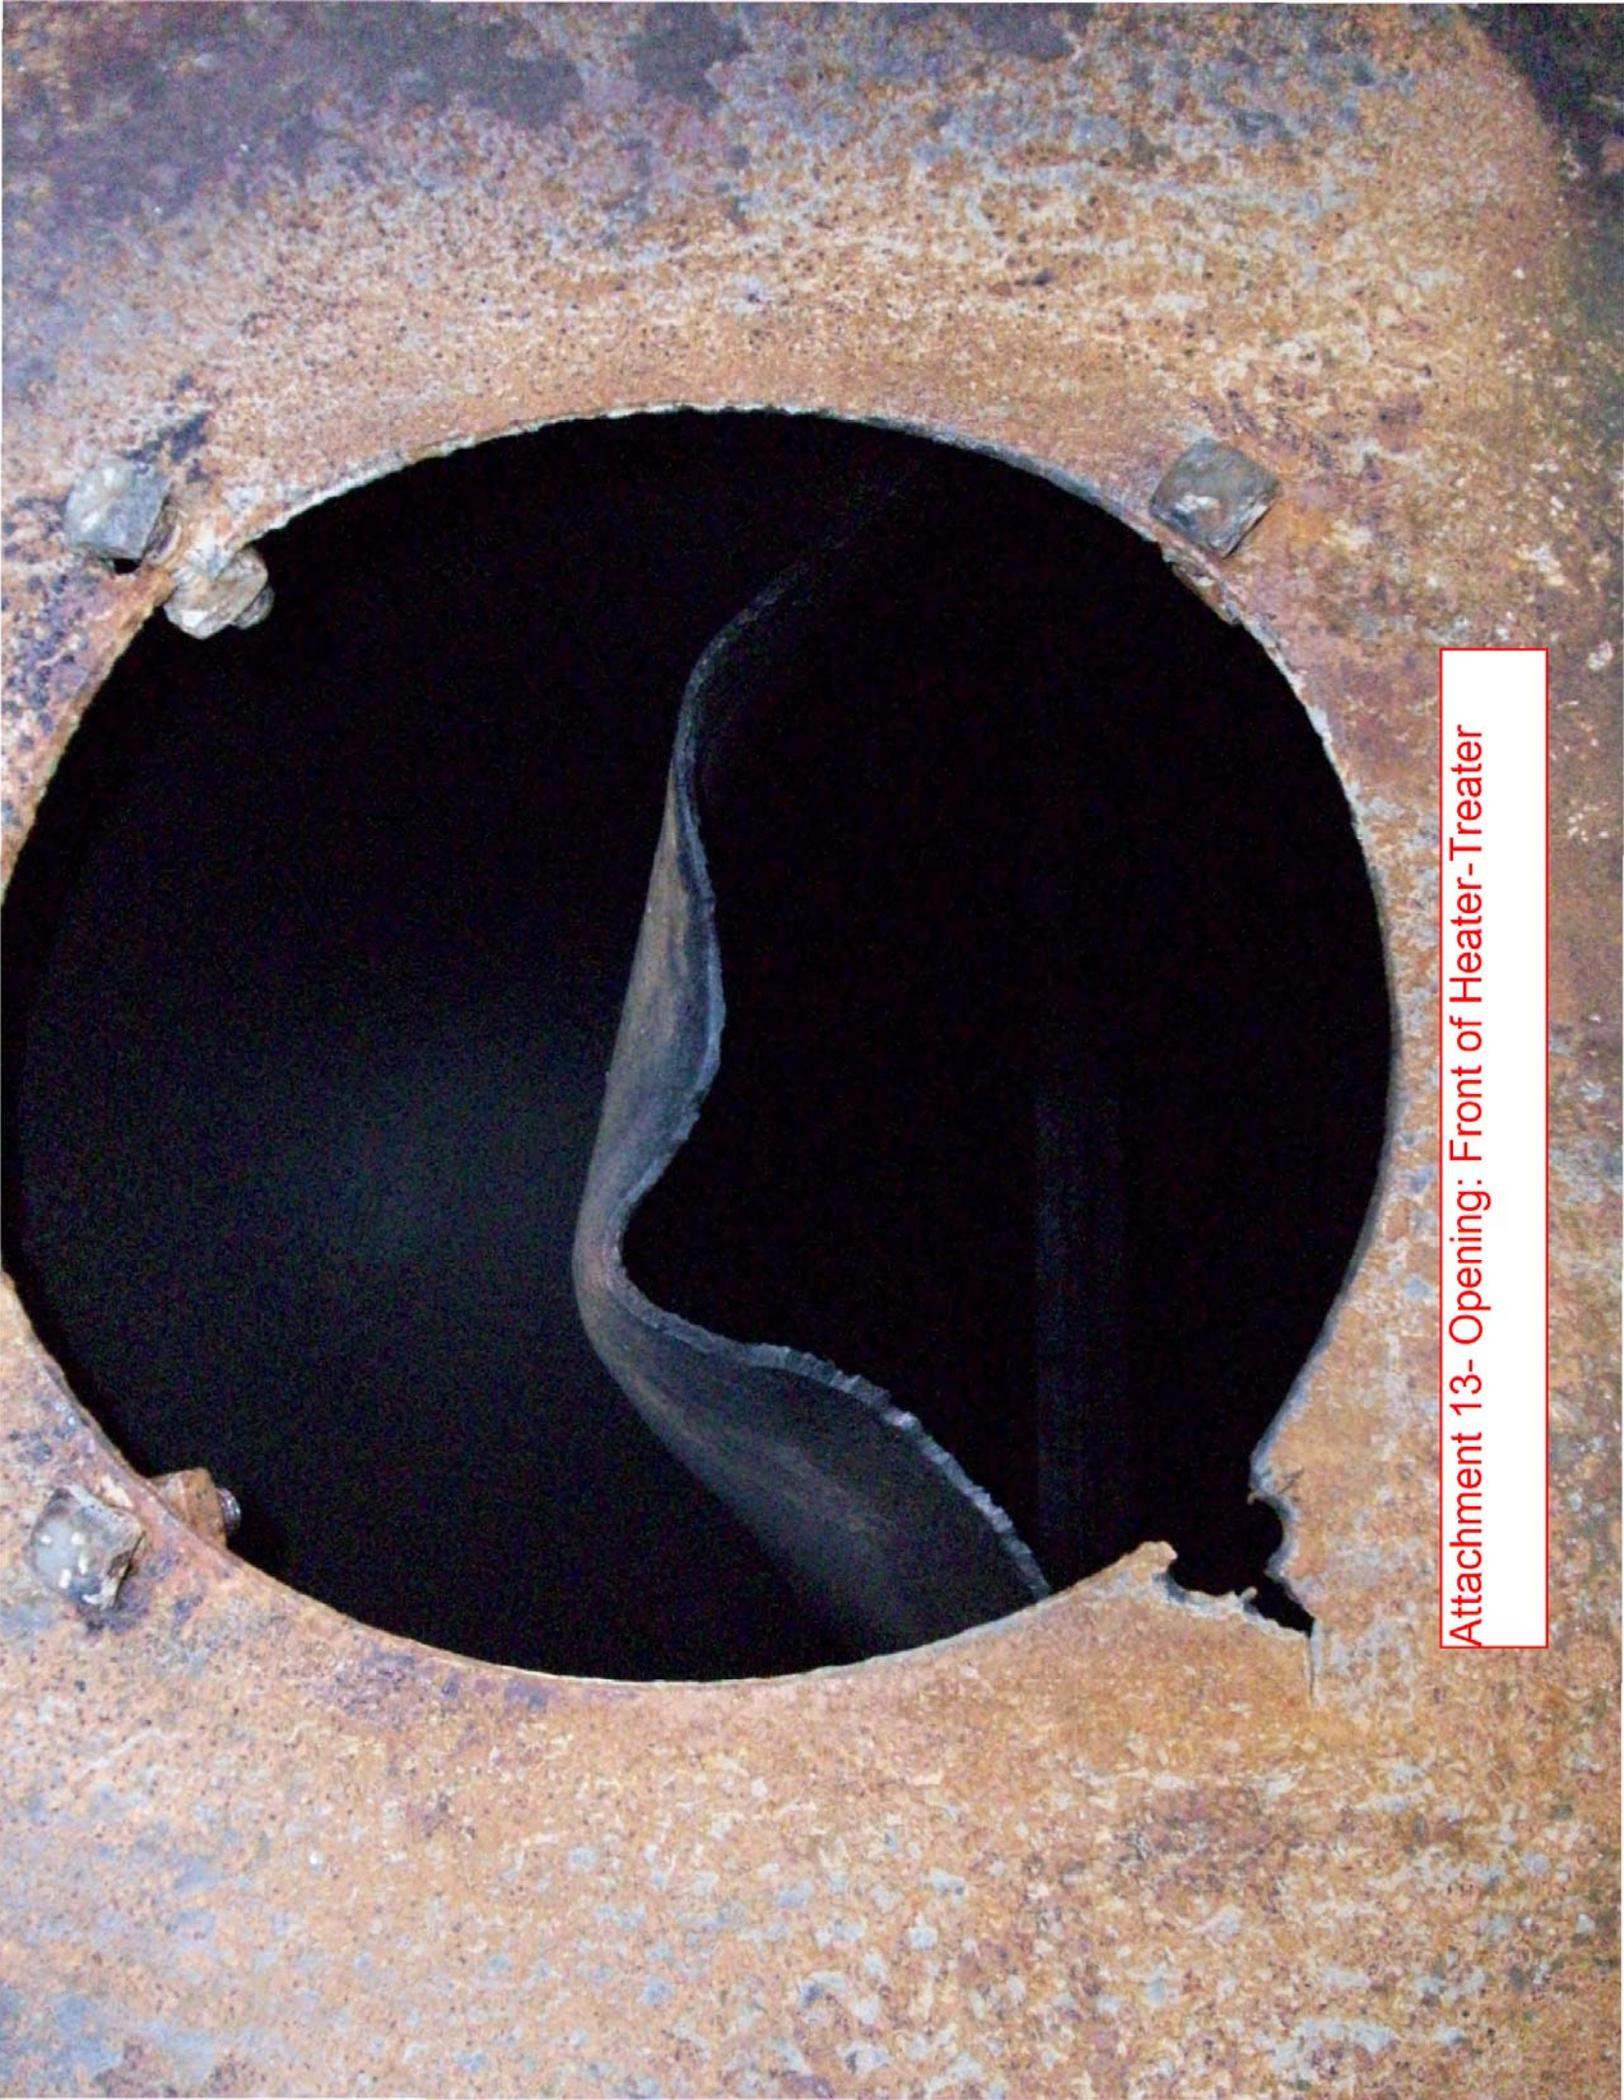
Attachment 13- Opening: Front of Heater-Treater

The Panel found that the immediate cause of the September 2 fire was that the Heater-Treater's fire tube collapsed in a "canoeing" configuration, which created openings in the vessel and fire tube through which hydrocarbons escaped. The hydrocarbons then came into contact with the Heater-Treater's hot burner, which ignited the hydrocarbons and ejected the component assembly section of the Heater-Treater. The ignition produced a noise that the crew described as an "explosion" and released hydrocarbons into the Gulf of Mexico.

All of these factors suggested that the fire tube was affected by heat that, in turn, contributed to the deterioration of the steel comprising the tube. *See Attachments 10-15, Photographs of the Heater-Treater.*
